# NONDESTRUCTIVE EVALUATION OF CERAMIC AND METAL MATRIX COMPOSITES FOR NASA'S HITEMP AND ENABLING PROPULSION MATERIALS PROGRAMS

Edward R. Generazio  
National Aeronautics and Space Administration  
Lewis Research Center  
Cleveland, Ohio 44135

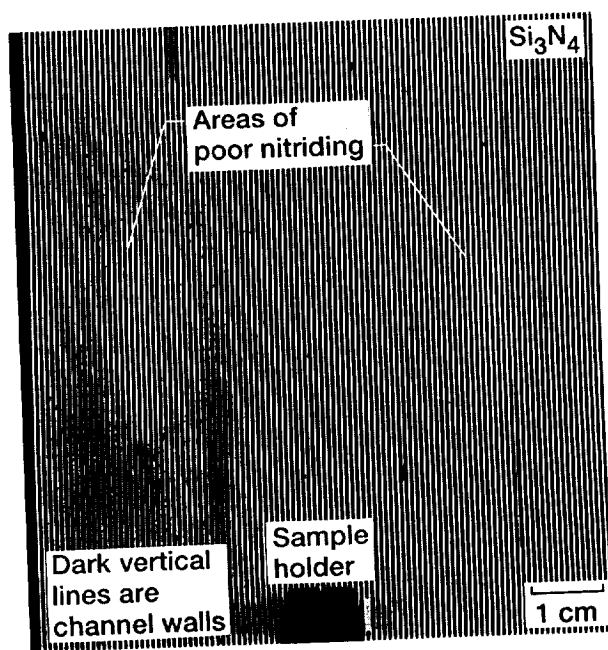
We begin our study with the development of a  $\text{Si}_3\text{N}_4$ /SCS-6 (ref. 15) panel that contains coolant channels (fig. 1). The actively cooled panel is made up of a monolithic, 10.0 by 10.0 cm,  $\text{Si}_3\text{N}_4$  slab that is laminated to a cross-ply composite panel  $\text{Si}_3\text{N}_4$ /SCS-6 [0-90]. The laminated panel is 0.335 cm thick. The monolithic panel has 0.05 cm wide and 0.05 cm high coolant channels. The channel walls are 0.05 cm thick. During the development of this panel the interlaminar bonding procedure is evaluated by bonding two similar but monolithic plates. The bond between planar layers may be evaluated with radiographic and through transmission, 10 MHz, ultrasonic c-scan analysis; the results are shown in figures 2 and 3, respectively. A low x-ray intensity, i.e., high x-ray attenuation, corresponds to dark region in the x-ray film positive. The dark vertical bands in the radiograph correspond to the walls of the coolant channels. The channels are uniform in shape and there are no chips, cracks or occlusions present. There are two lighter vertical bands at areas where poor reaction of the bonding material produced low densities. (A subsequent modification of the manufacturing process eliminated these poorly reacted areas.) The

Figure 2.—Radiograph of monolithic Si<sub>3</sub>N<sub>4</sub>, actively cooled panel.

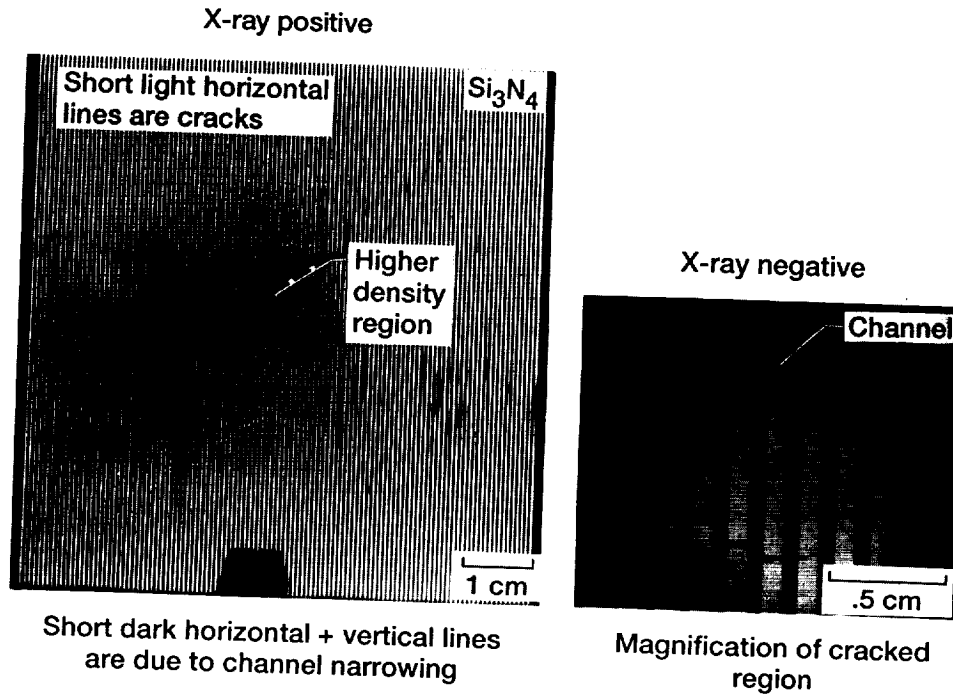
Figures 4 and 5 show the radiographic and 10 MHz, ultrasonic c-scan results for a  $\text{Si}_3\text{N}_4/\text{SCS-6}$   $[0^\circ]$  panel. Severe microcracking is observed in the radiograph as short light horizontal lines. The microcracks are most visible at the walls of the coolant channels. Note that in the enlarged region of the radiograph the crack lengths are not limited to the channel wall thickness but actually are several channels wide. The short dark vertical lines scattered throughout the image each have a short horizontal dark line at their central regions. These short dark vertical regions are regions where the channel has decreased in width. The dark horizontal line at the center of each of these regions, when examined at high magnifications, has been found to be an optical illusion that occurs where the channel walls have the closest approach to each other. At the region of closest approach some channels are partially blocked by this narrowing of the channel. Several channels had adjacent walls that were of sufficient thickness that the walls were touching and apparently completely blocking the channel. The ultrasonic image reveals a considerable amount of disordered mottling in the structure. The radiograph does exhibit density variations. There is no correlation between the mottling structure in the ultrasonic c-scan image and the crack structure observed in the radiograph. This mottling is due to porosity and bond variations between the laminated layers (refs. 16 to 22).

Figure 4.—Radiographs of  $\text{Si}_3\text{N}_4$ /SCS-6 [0 degree] actively cooled panel.

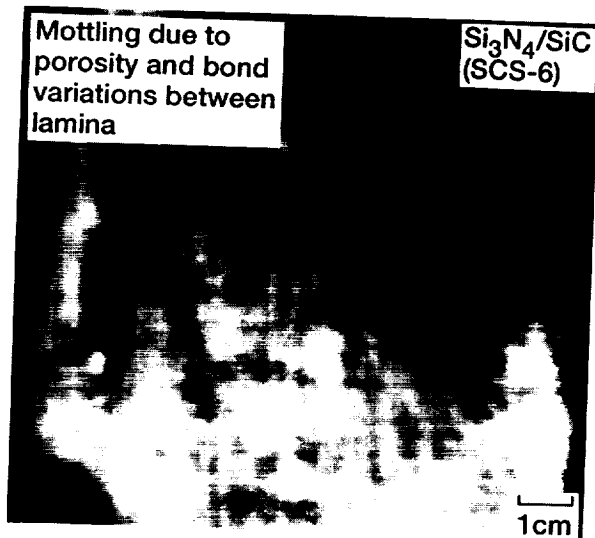
Figure 5.—Ultrasonic, 10 MHz through transmission c-scan of  $\text{Si}_3\text{N}_4$ /SiC SCS-6 [0 degree] actively coolant panel.

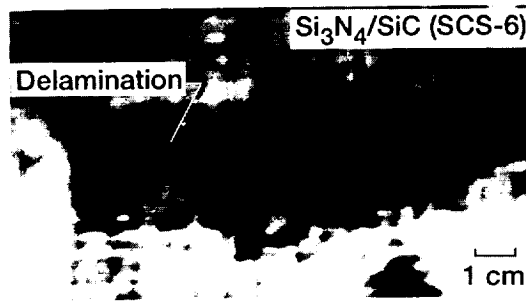
In the previous example the fiber orientation is not easily determined. Figures 6 and 7 show the radiographic and 10 MHz, ultrasonic, c-scan images of a  $\text{Si}_3\text{N}_4/\text{SCS-6}$   $[0/90^\circ]$  composite panel that does not have coolant channels. The radiograph reveals a bowed fiber system. These bowed patterns are not actual individual bowed fibers but are x-ray "shadows" of a collection of fibers that are bowed. The shadows forming the bowed pattern are due to fiber volume density variations through the thickness and perpendicular to the x-ray film plane. This is manifestation of the Moiré effect (refs. 18 and 23) found in composite systems. The density of the system is uniform as indicated by the uniform gray level or shading in the radiograph. The dark areas in the ultrasonic image also yielded reflected ultrasonic signals that corresponded to reflections from the laminated boundary, these dark areas are regions having poor or no bond between laminated layers.

Figure 7.—Ultrasonic, 10 MHz, through transmission c-scan of  $\text{Si}_3\text{N}_4/\text{SiC}$  SCS-6 [0-90 degree] panel.

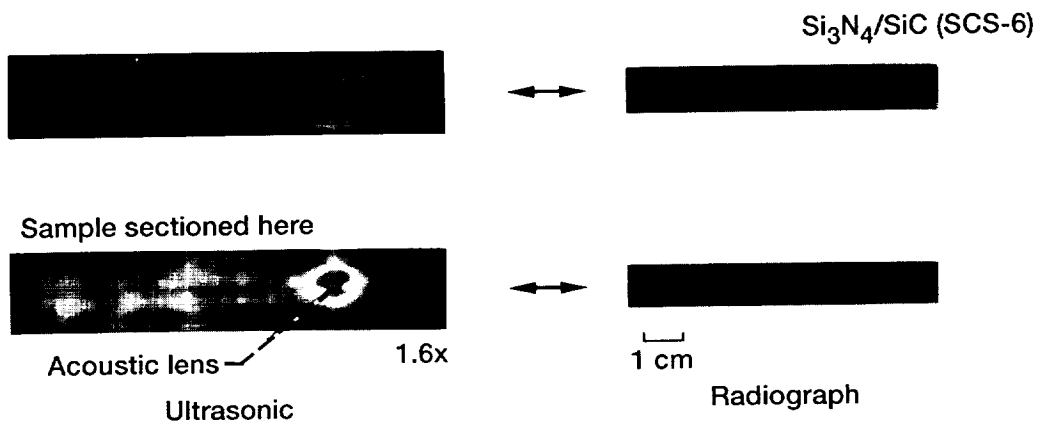
Fibers need only be well ordered and spaced uniformly in the plane of a  $\text{Si}_3\text{N}_4/\text{SCS-6}$   $[0/90]$  plate in order to yield relatively uniform radiographic and ultrasonic images (fig. 8). However, if there are any systematic variations, such as, ordered through the thickness buckling (due to processing) of the fibers (fig. 9), then the ultrasonic image will reveal this systematic fiber spacing variations. The fiber buckling can be readily observed in the photomicrograph (fig. 9) by comparing the spacing between the bottom two rows of fibers that are perpendicular to the cross section. Note that this spacing varies dramatically from center to the right edge of the sample. In this case, the fibers are forming a crude diffractive/refractive acoustic lens (fig. 9) that is observed as a bright spot in the ultrasonic image. No indication of this fiber buckling is seen in the radiograph.

Figure 8.—Ultrasonic, 10 MHz, through transmission c-scan and radiographs of similarly produced  $\text{Si}_3\text{N}_4/\text{SiC}$  SCS-6 [0-90 degree], test bars.

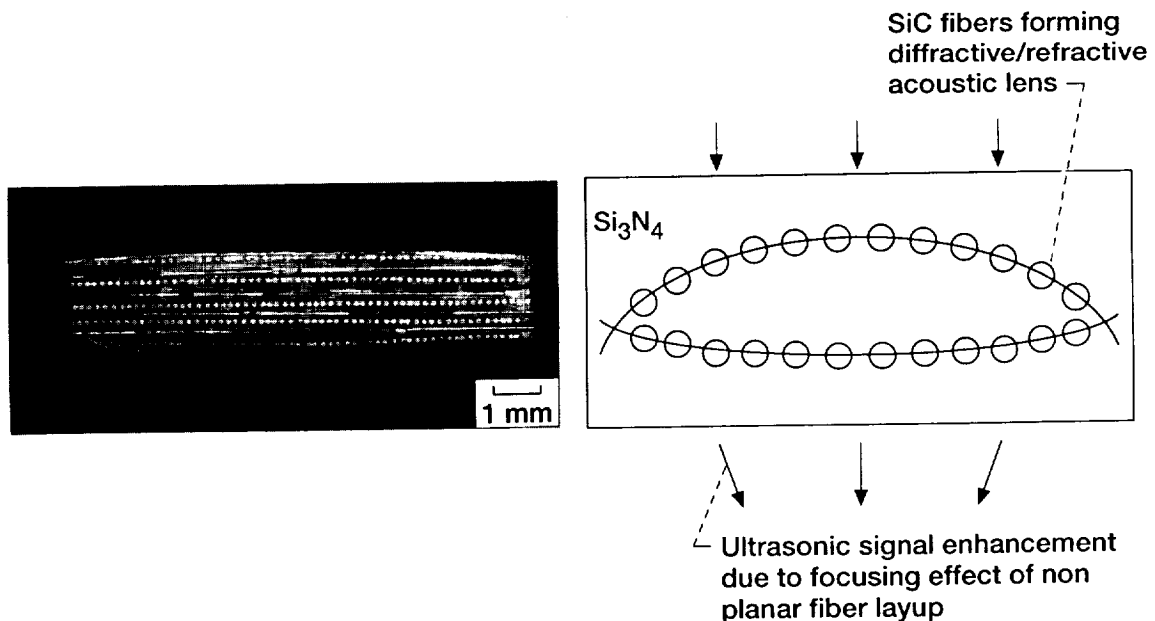
Figure 9.—Cross-section of  $\text{Si}_3\text{N}_4/\text{SiC}$  SCS-6 [0-90 degree] test bar at region showing large ultrasonic transmission.

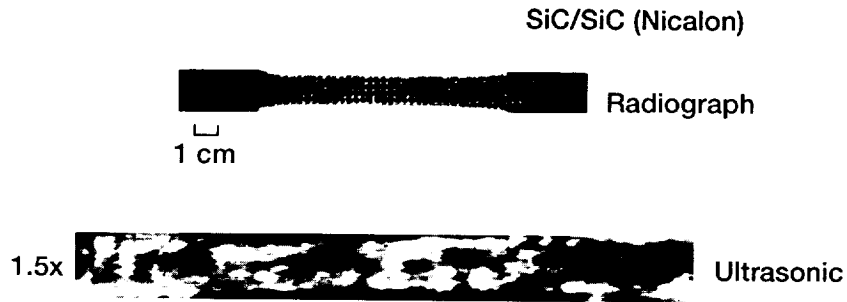
A  $\text{SiC}/\text{SiC}$  (Nicalon fiber) laminated, two-dimensional, woven composite yield very complicated radiographic and 10 MHz, ultrasonic c-scan (fig. 10) images. The radiograph reveals a cross hatch pattern that varies in density. This variation may be due to density variations in the matrix material or registration variations between the woven layers. The dark circular regions that are uniformly spaced are due to local density variations that have been produced during processing. These circular density variations are also visible in the ultrasonic image. The distorted or blurry appearance of the ultrasonic images

is due to refractive and diffractive scattering (ref. 17) occurring at the rough surfaces and woven fibers. There is little additional information obtained from the 10 MHz, ultrasonic c-scan.

Figure 10.—Ultrasonic, 10 MHz through transmission c-scan and radiograph of SiC/SiC (Nicalon) woven laminated composite.

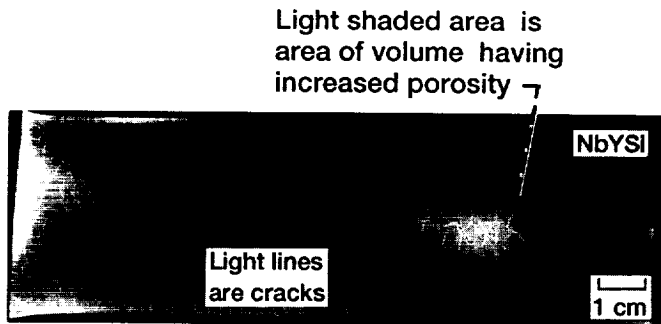
During the development of potential metal matrices the processing procedures are optimized by a combination of methods. One technique developed for consolidating metallic glass powders requires the use of a molybdenum or niobium encapsulating can for hot isostatic pressing (HIP). Radiographic (fig. 11) and ultrasonic (fig. 12) imaging can be performed while the consolidated material, NbYSi is still encapsulated. The radiograph reveals an extensive amount of cracking throughout the consolidated material. Regions of increased porosity can be readily identified as light cloud-like areas in the radiograph and dark areas in the ultrasonic image. The crack density increases with an increase in porosity.

Figure 11.—Radiograph of encapsulated NbYSi matrix material.

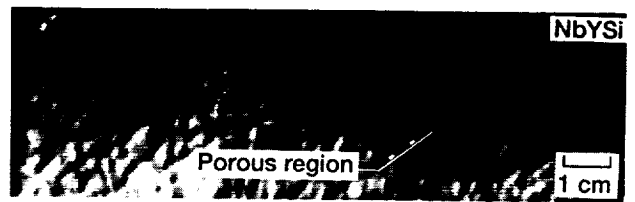
Figure 12.—Ultrasonic, 10 MHz, through transmission c-scan of encapsulated NbYSi matrix material.

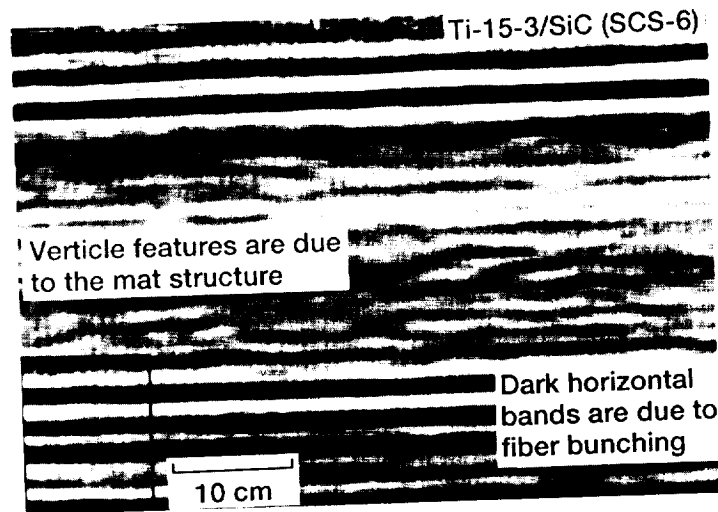
Composites with three phases yield complex radiographic and ultrasonic data. A Ti-15-3 plate containing unidirectional SiC (SCS-6) fibers and a molybdenum wire mat represents a simple three phase composite system. Groups of molybdenum wires can be identified in the 10 MHz, ultrasonic c-scan image (fig. 16) as faint uniformly spaced vertical lines. Here each group of mat wires act as an ultrasonic line scatter. Dark horizontal bands in the upper and lower parts of the ultrasonic image are due to the slight bunching of the horizontal SiC fibers, i.e., areas having high fiber volume density. The central region of the ultrasonic image also exhibits some horizontally oriented mottling. This mottling is due to similar fiber volume density variations except that these fiber volume density variations are not as ordered as those near the upper and lower edges of the plate. The radiograph shows both the orientation and structure of the horizontal SiC fibers and the vertical molybdenum wires that make up the mat (fig. 17). Broken, twisted, and bent molybdenum wires are easily identifiable and occur throughout the system. Fiber rich banded zones can also be identified, but not easily, in the radiograph.

Figure 16.—Ultrasonic, 10 MHz, through transmission c-scan of Ti-15-3/SiC (SCS-6) composite.

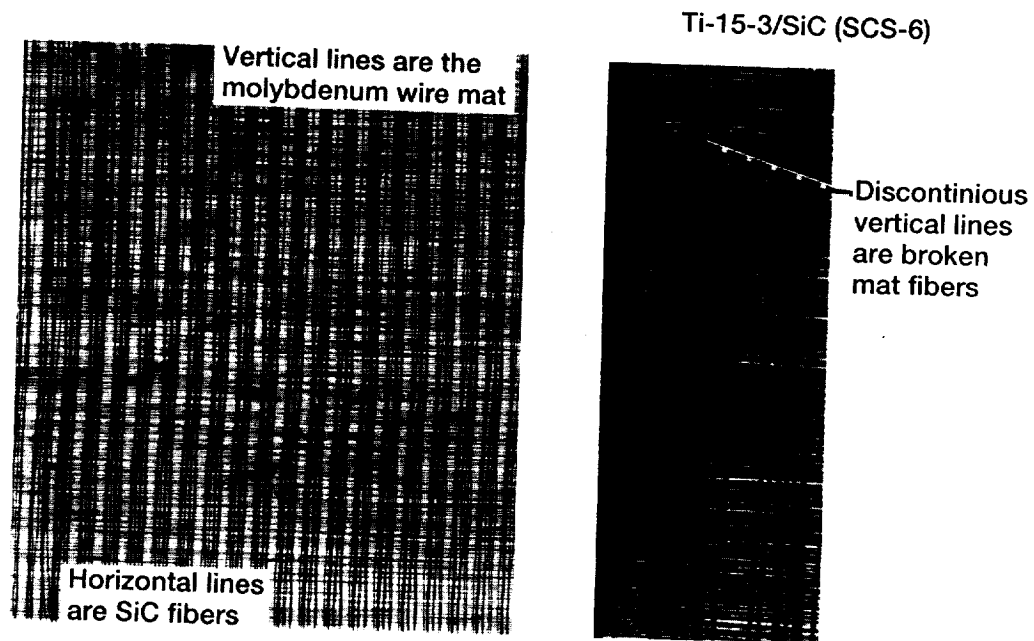
Figure 17.—Radiograph of highlighted region in figure 16.

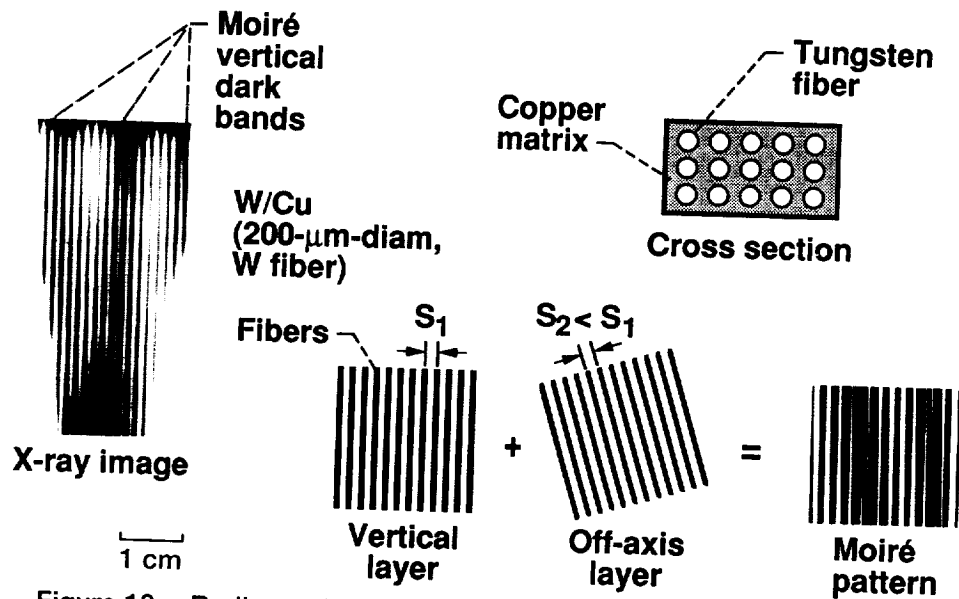
Ordered or systematic changes in the fiber volume density or orientation can produce artifacts or Moiré (refs. 17 and 23) patterns in the radiographs. For example, if in one layer, the fiber spacing, S1, is slightly different from the fiber spacing, S2, in another layer, then a Moiré pattern will be observed in the radiograph. The radiograph of a copper matrix system containing tungsten wires (fig. 18) reveals broad vertical dark Moiré bands. (This is not an advanced high temperature composite material for the HITEMP or EPM programs, but it does dramatically show an artifact that occurs in all continuous fiber composites to some degree.) In addition, if the fiber layers are also off-axis from each other then the Moiré bands will also be off-axis.

Figure 18.—Radiograph and illustrations showing Moiré effect in W/Cu composite.

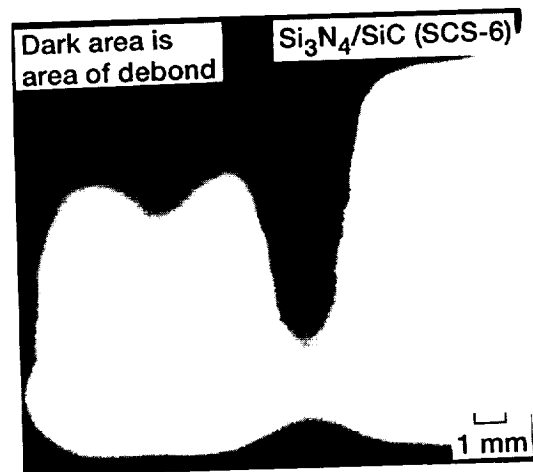
An extensive amount of ultrasonic scattering is observed in a 10 MHz, ultrasonic c-scan (fig. 25). The dark areas in the ultrasonic image correspond to the areas where cracks are observed in the DERC image.

Figure 25.—Ultrasonic, 10 MHz, through transmission c-scan of section of  $\text{Si}_3\text{N}_4/\text{SiC}$  SCS-6 [0] RBSN tensile test bar.

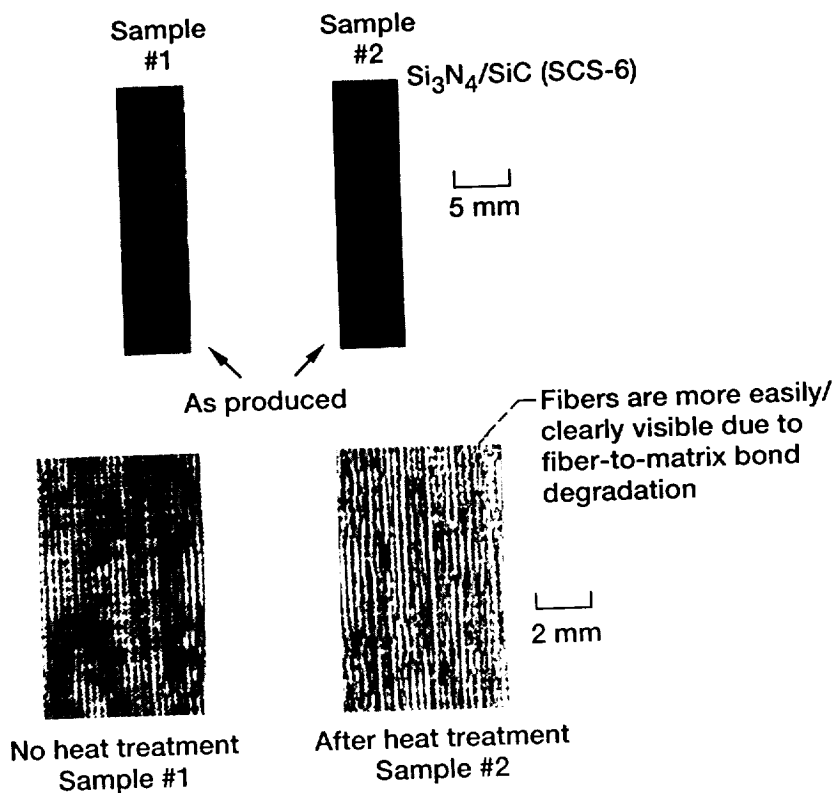
Two identically produced specimens of  $\text{Si}_3\text{N}_4/\text{SiC}$  (SCS-6) [0] were ultrasonically evaluated using the DERC technique. The DERC images are spatially filtered with a two-dimensional high pass filter before further evaluation. This filter extracts the important spatial high frequency components (i.e., reflections from the fiber-to-matrix interface) from the reflections from porosity which are generally observed as mottling in ceramics (refs. 16 to 22 and figs. 5 and 7). The DERC results reveal similar features in both samples before heat treatment (fig. 26). The vertical features in these images are due to reflections at the subsurface fiber-to-matrix interfaces. One sample was heat treated at 600 °C for 100 hr in flowing oxygen to degrade the fiber-to-matrix interface (via oxidation) (ref. 24). This heat treatment decreased the interfacial shear strength from  $18 \pm 4$  MPa to  $0.8 \pm 0.4$  MPa (ref. 24). After heat treatment there is a marked change in the DERC image. After heat treatment the reflections from the interface are more intense so that the fibers become more visible. This change in the DERC results before and after heat treatment can be quantified. The histogram maximum of the gray scale of each of the images may be used to quantify the DERC results (fig. 27). A low value for the histogram maximum indicates that there is considerable amount of scattering at the fiber-to-matrix interfaces per unit area. A high maximum value indicates that the fibers are difficult to observe and that the image is rather bland or smooth. Ideally, if the fibers were perfectly bonded, and therefore essentially unobservable (except for the small variation in the acoustic impedance between the fiber and matrix) then the DERC images would contain predominantly one shade, 128, in the gray scale. The gray scale maximums for the untreated and heat treated specimens are

Figure 26.—DERIC images of  $\text{Si}_3\text{N}_4/\text{SiC}$  SCS-6 [0] RBSN at 50 MHz before and after heat treatment.
